MISCELLANEOUS PAPER GL-91-13

INVESTIGATION OF AIRFIELD RUNWAYS AT JACKSONVILLE NAVAL AIR STATION

June 1991

Final Report

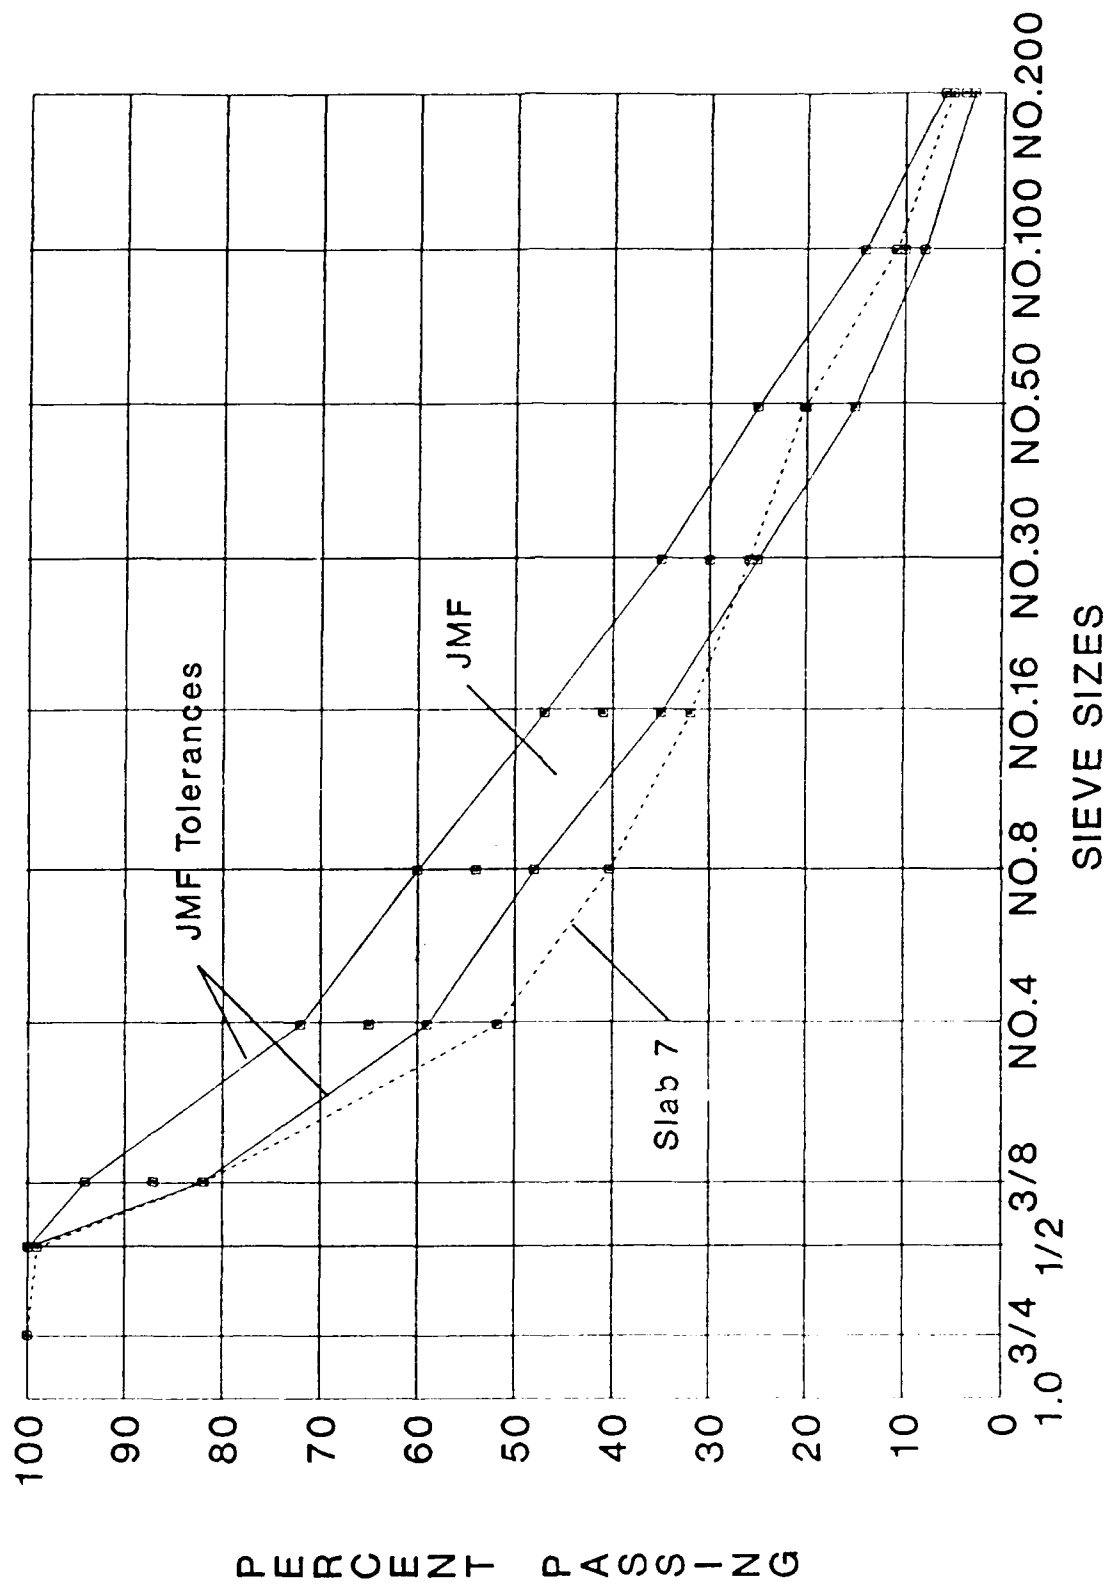
The aggregate gradations determined from slab samples taken from Runway 14/32 are inconsistent. Slab sample 7 had a gradation that did not meet the specifications and was similar to the coarse aggregate gradations found on Runway 9/27. Slab sample 8 had the only aggregate gradation that was close to meeting the required contract specifications.

Figure 9. Aggregate gradation - Slab 7

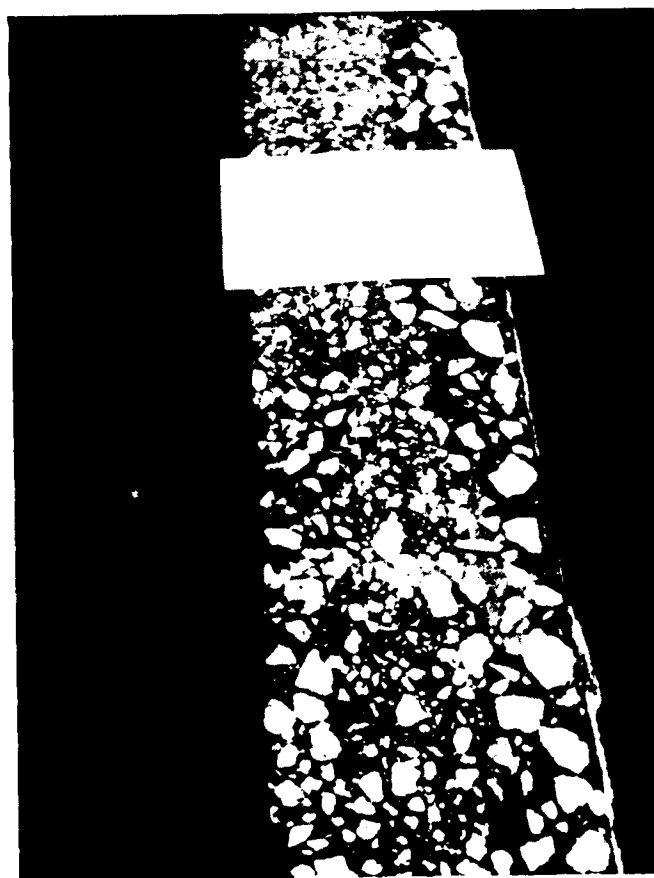
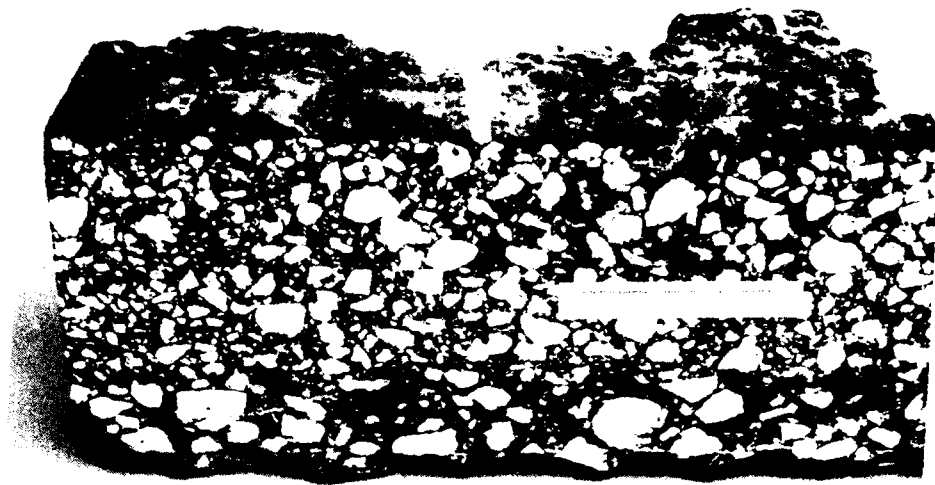
A complete laboratory analysis was conducted on each of the eight slab samples. Due to the condition of Slab 1 (Photos 5-8), two separate sets of tests were conducted for the raveled and nonraveled portions of the slab. A total of nine individual samples were evaluated. The laboratory evaluation for each sample included extractions, asphalt recoveries, recompaction analyses, and material tests.

Photo 5. Pavement surface - Slab 1

Photo 6. Cross section - Slab 1

Photo 7. Sawed face of Slab 1

Photo 8. Broken face of Slab 1

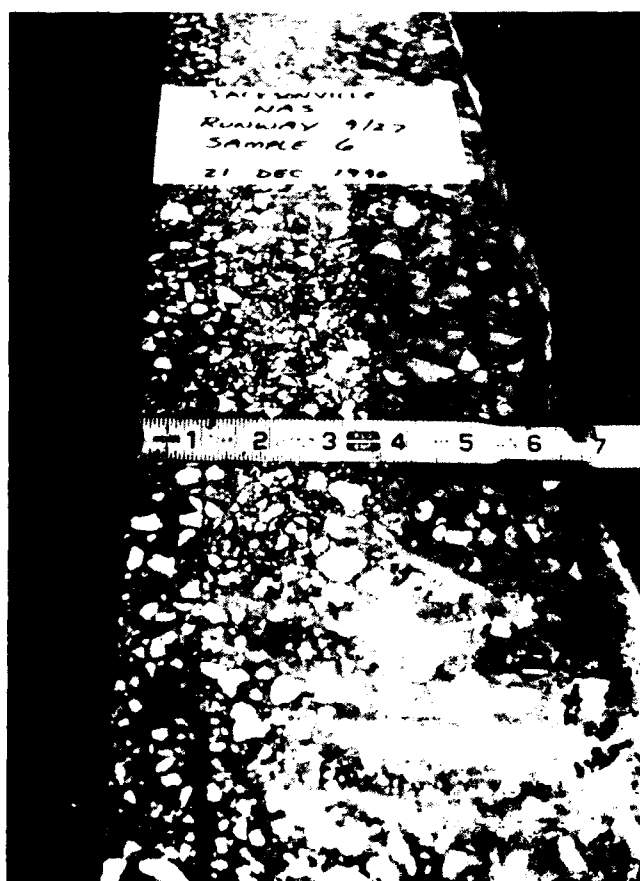
On 17 December 1990, the eight slab samples arrived at the WES pavement laboratory. The samples were intact and undamaged from shipping. Photos 4-22 show the condition of the pavement samples upon arrival at WES prior to testing. Photos 5, 11, 13, 15, 17, and 19 show that surface raveling had occurred in these pavement slab samples. Photos 6, 7, 12, 14, 16, 18, and 20 show a large number of internal voids in asphalt concrete mixture.

Photo 18. Cross section - Slab 6

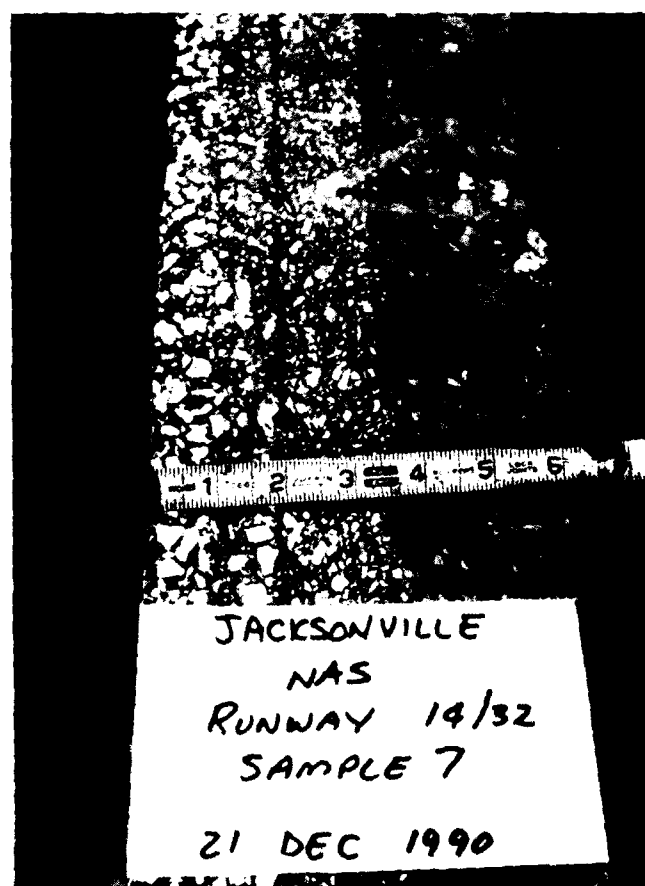
Photo 20. Cross section - Slab 7

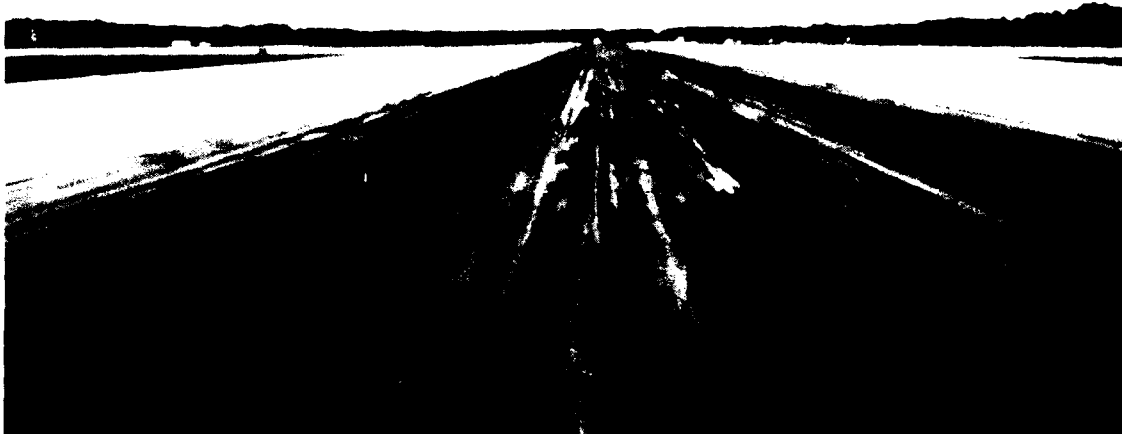
4. On 6 November 1990, the airfield pavement was inspected during the normal maintenance shut down period, 0800-1000. The overall appearance of Runway 9/27 indicated the asphalt concrete material was losing the fine aggregate and raveling. The touchdown zone area near the center line was exhibiting the most severe raveling. The pavement had excessive rubber build-up and an open-textured appearance. Figures 1 and 2 show the typical condition of Runway 9/27. Specific observations and defects observed in Runway 9/27 are listed below:

Figure 1. Typical view of Runway 9/27

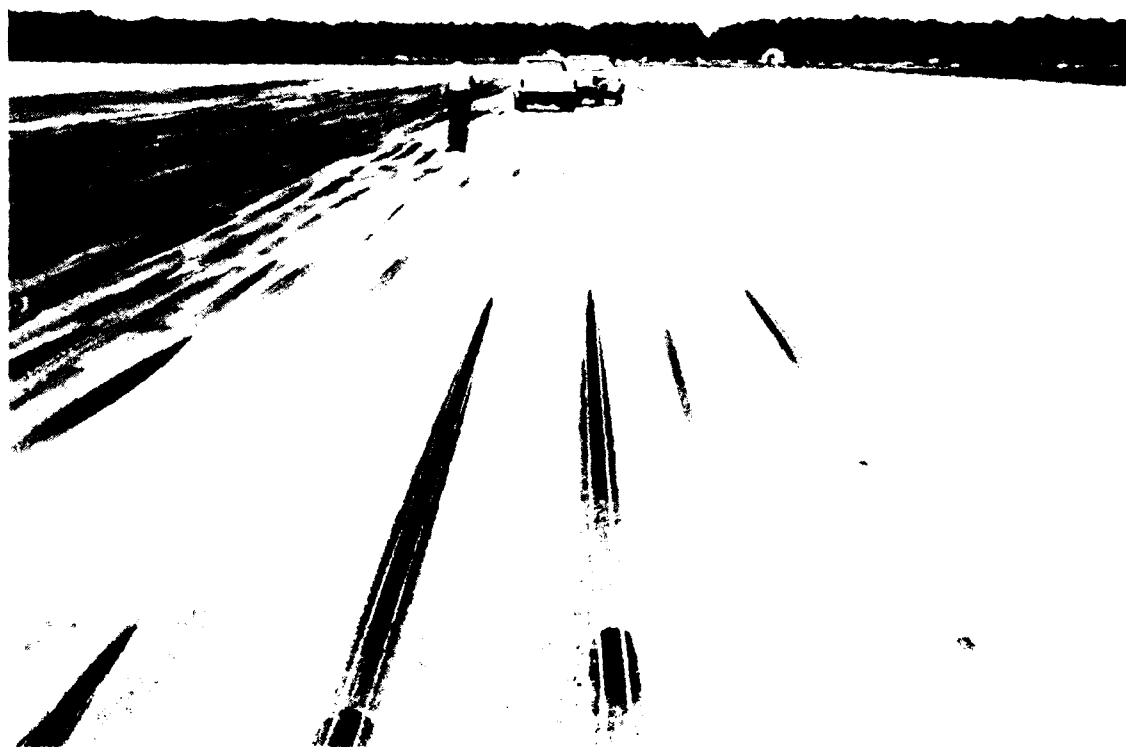
In the previous visual inspection on 6 November, it was observed that an obvious color difference existed between the outside paving lanes and the inside lanes. Slab samples 2 and 5 were taken from the outside lanes. The ductility values indicated that there was a difference in the asphalt cements. The ductility values for slab samples 2 and 5 were 2 to 4 times greater than the other slab samples, indicating that this binder was not as brittle and hard as the asphalt cements of the inside lanes.

Figure 10. Two distinctive colors in asphalt concrete mixture.

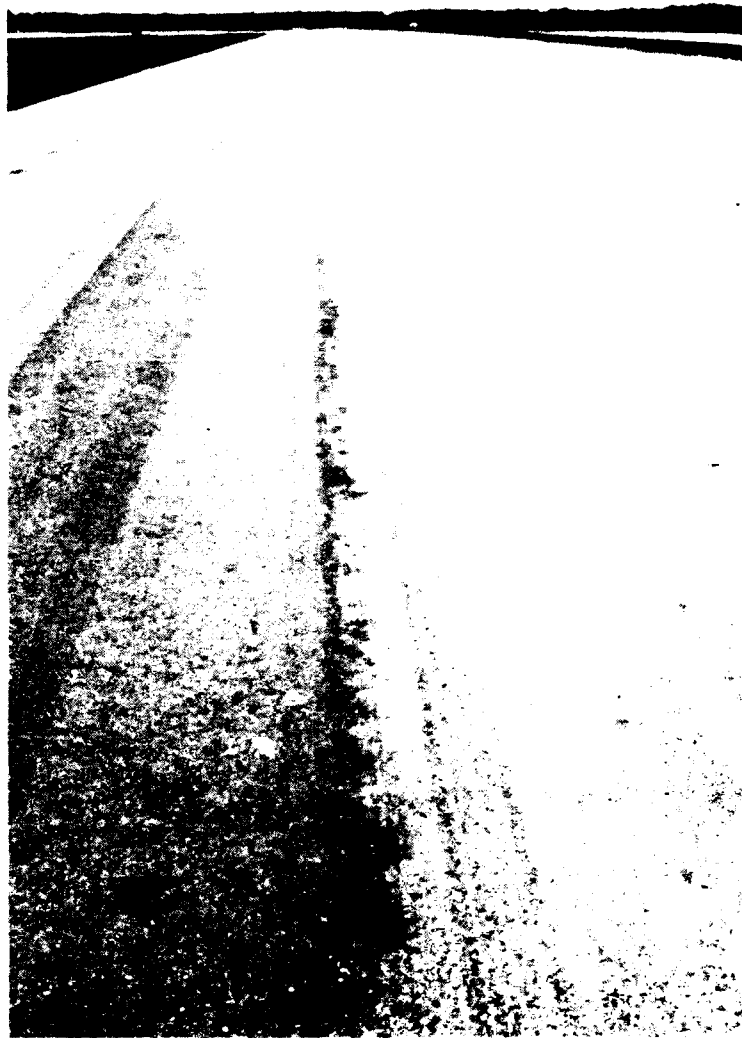
i. Ravelled material and stains on longitudinal construction joint (Figure 11).

Figure 11. Brown stains alongside longitudinal joint
